# California State Lands Commission

## Prevention First 2002

### Rehabilitation of State Lease 421

September 10, 2002

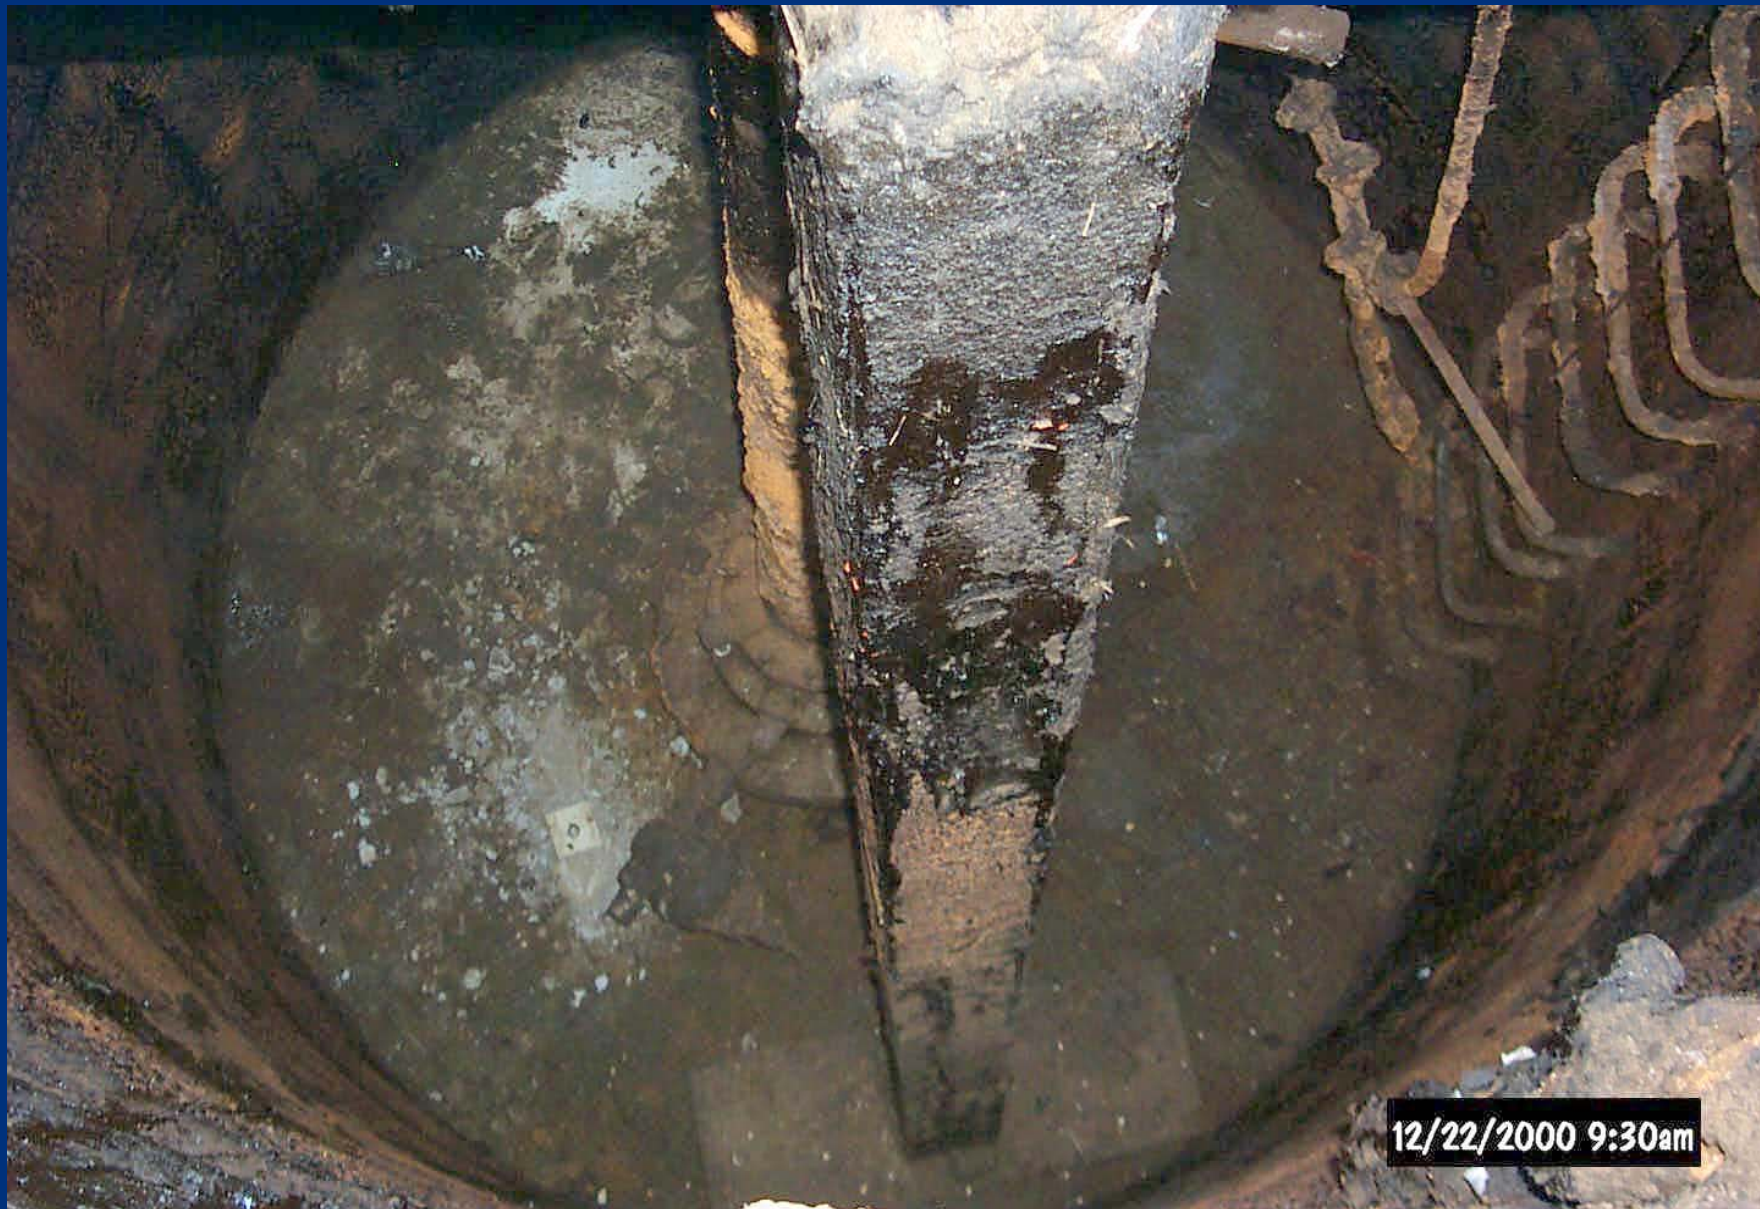
12/22/2000 9:30am

- November 22, 2000      Methane gas leak detected during an APCD inspection of the facilities. A fugitive leak that needed to be repaired was detected.
- November 28, 2000      Oil leak caused by an acoustic level check of the two wells. The testing pressure caused a 2" nipple on the well casing to fail. This resulted in a 15-gallon leak.

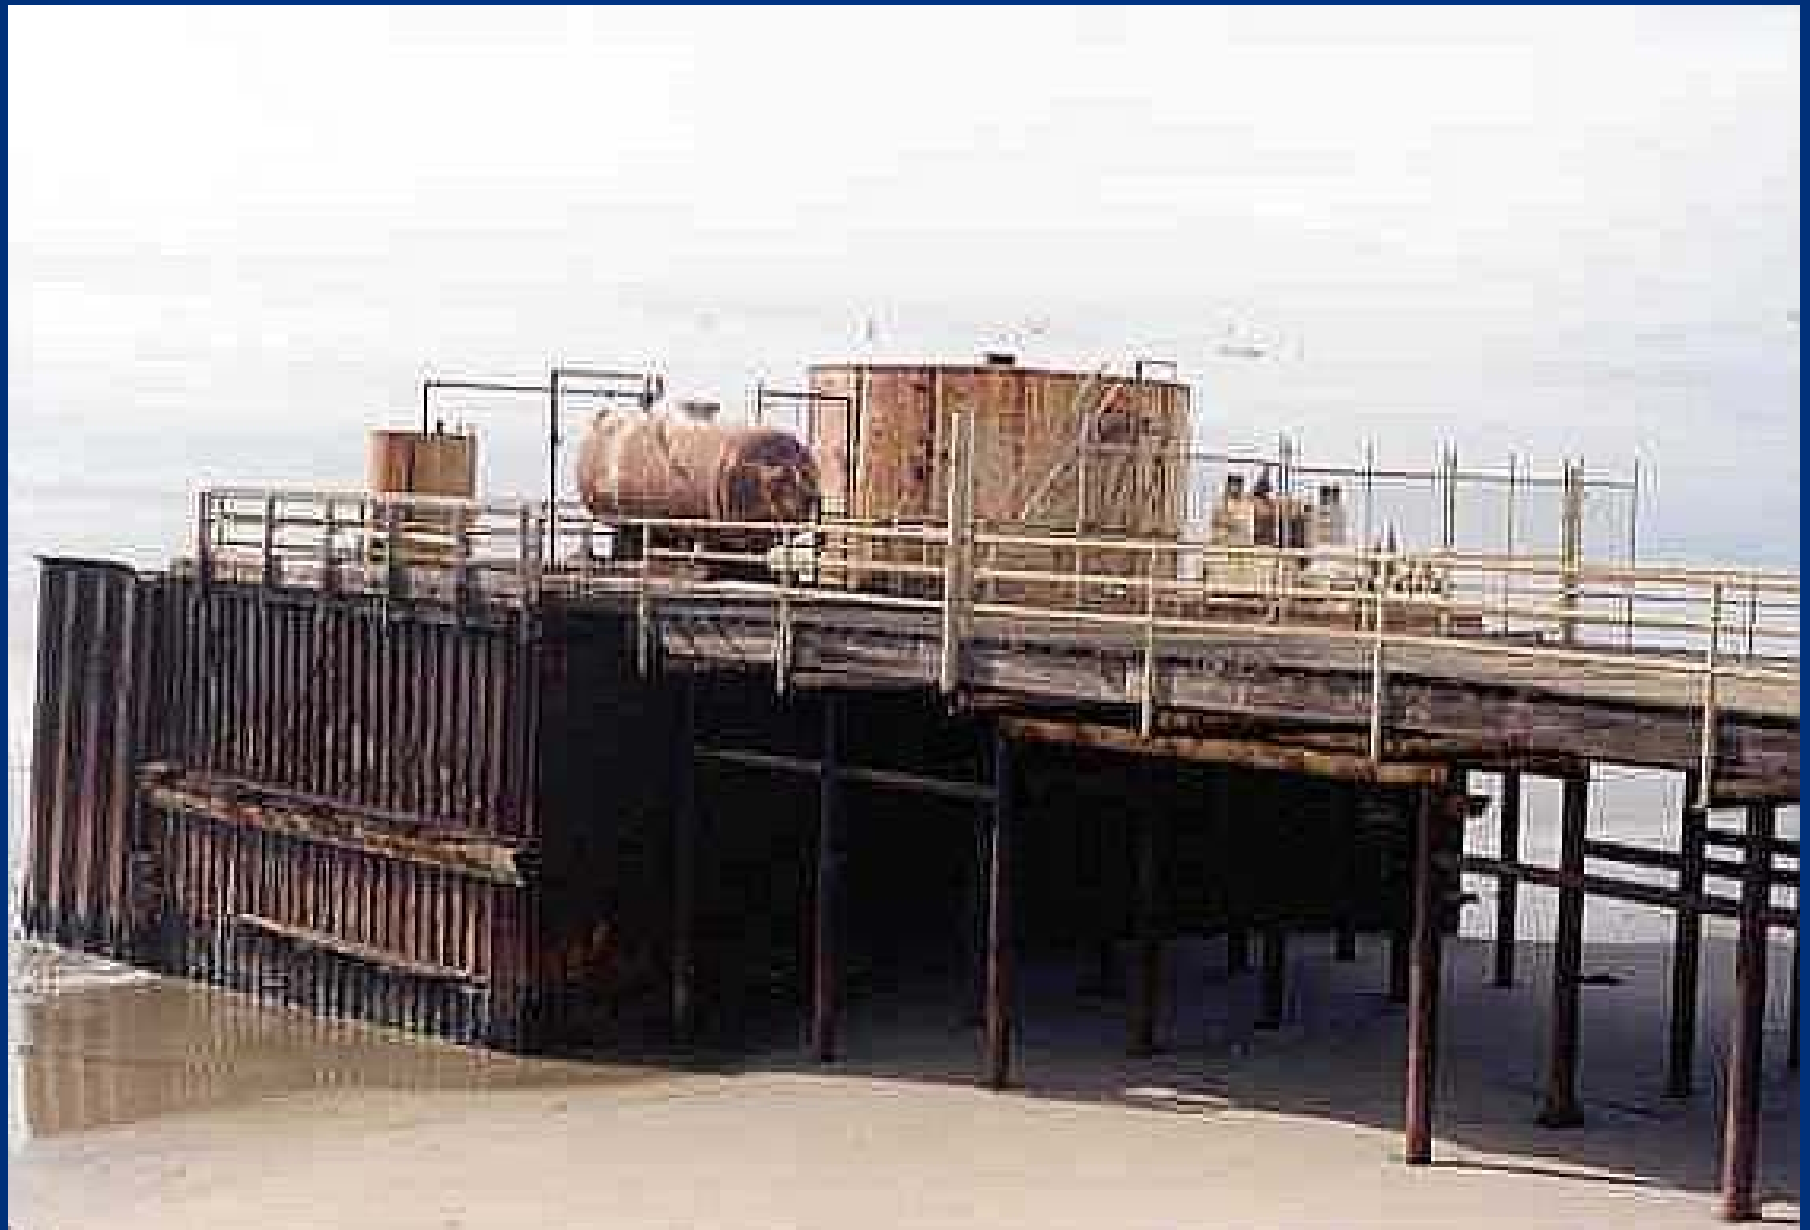
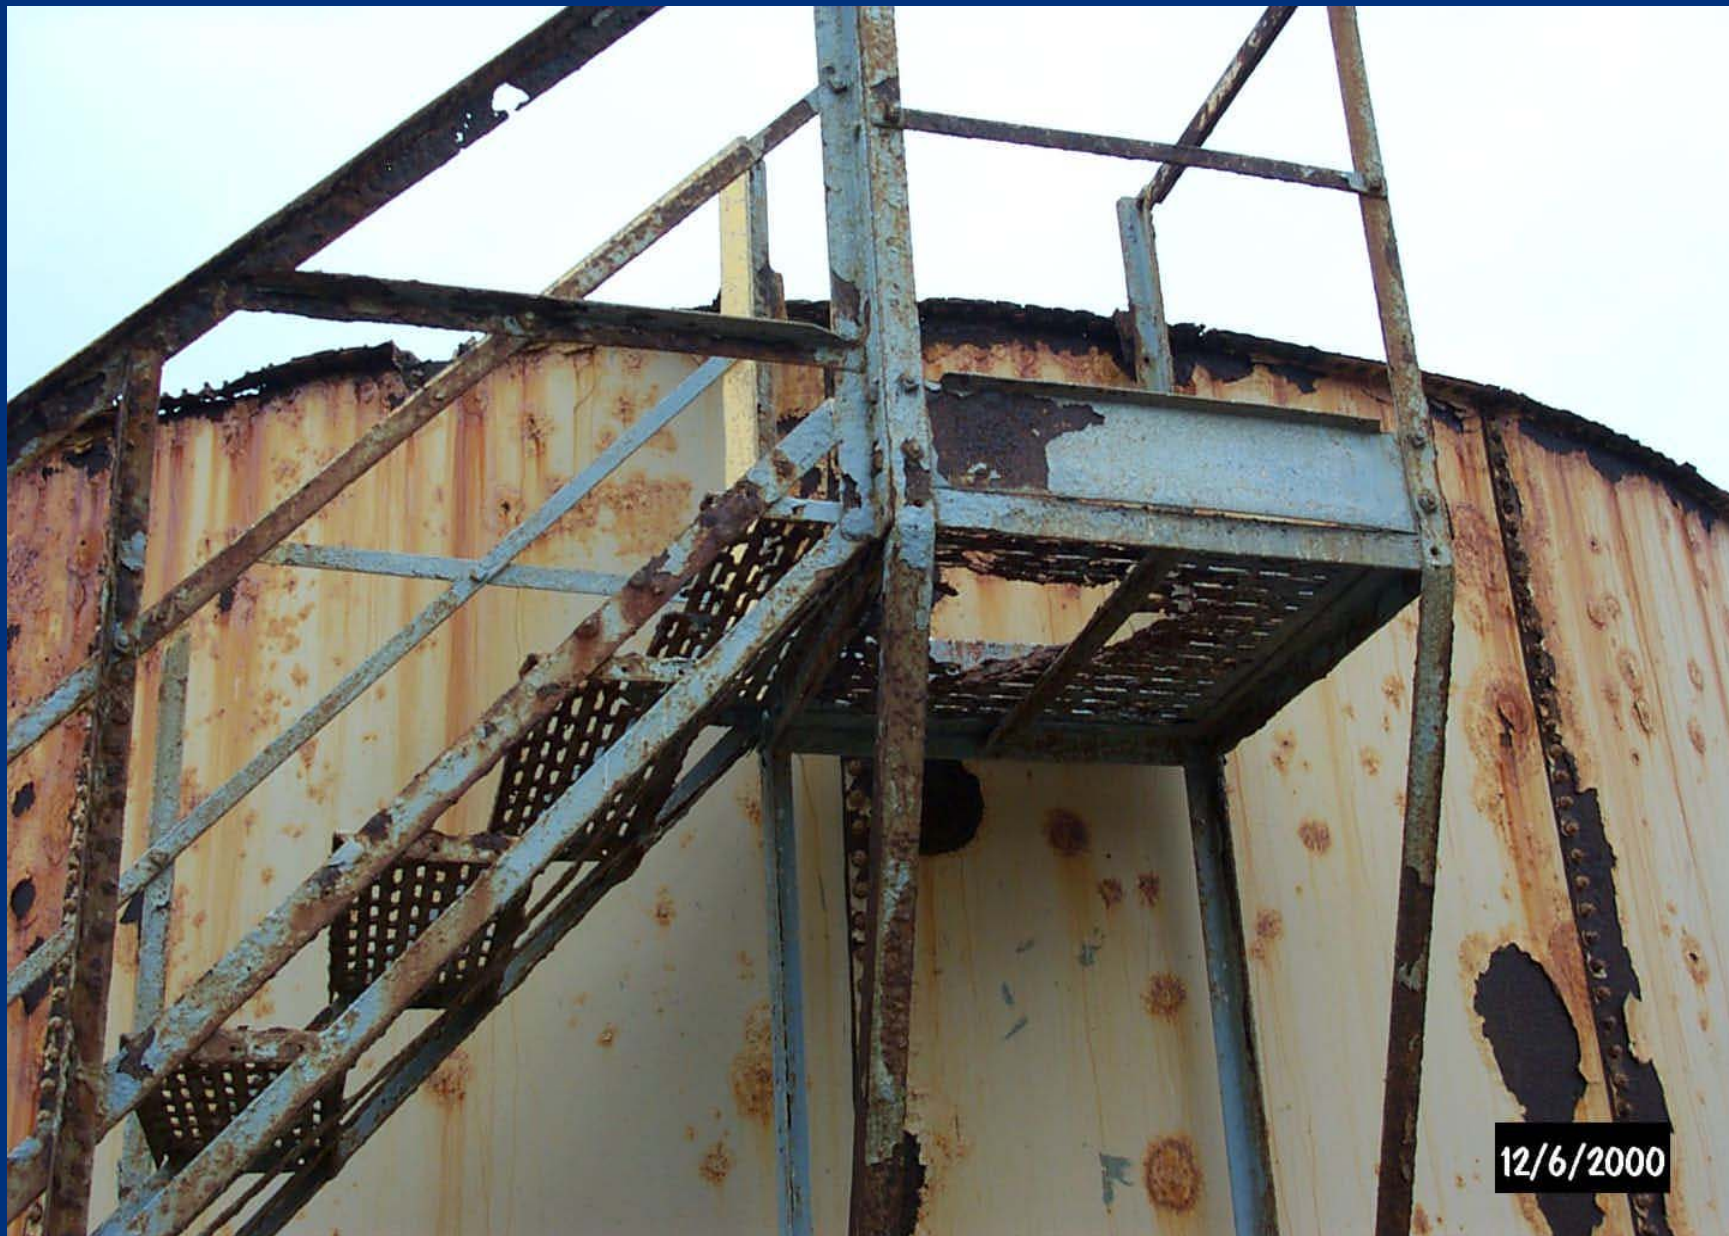
12/6/2000

- Afternoon of November 28, 2000 Management notified of the leak
- Activated Emergency Response Plan
- Made appropriate notifications including “911” and local and state agencies
- Access limited due to condition of the road, piers, and caissons
- How do we ensure the wells are safe?

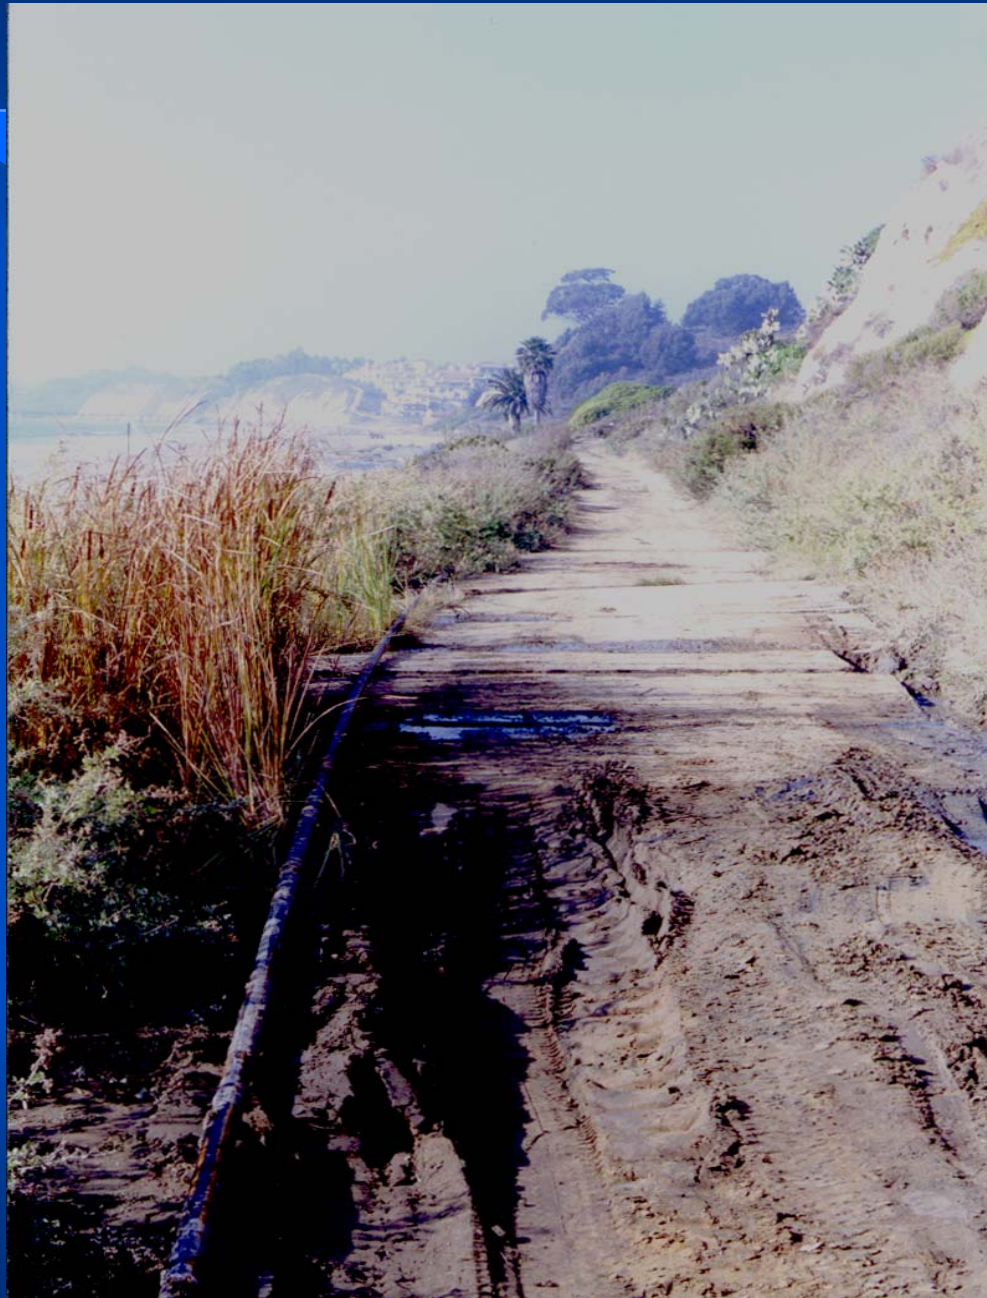
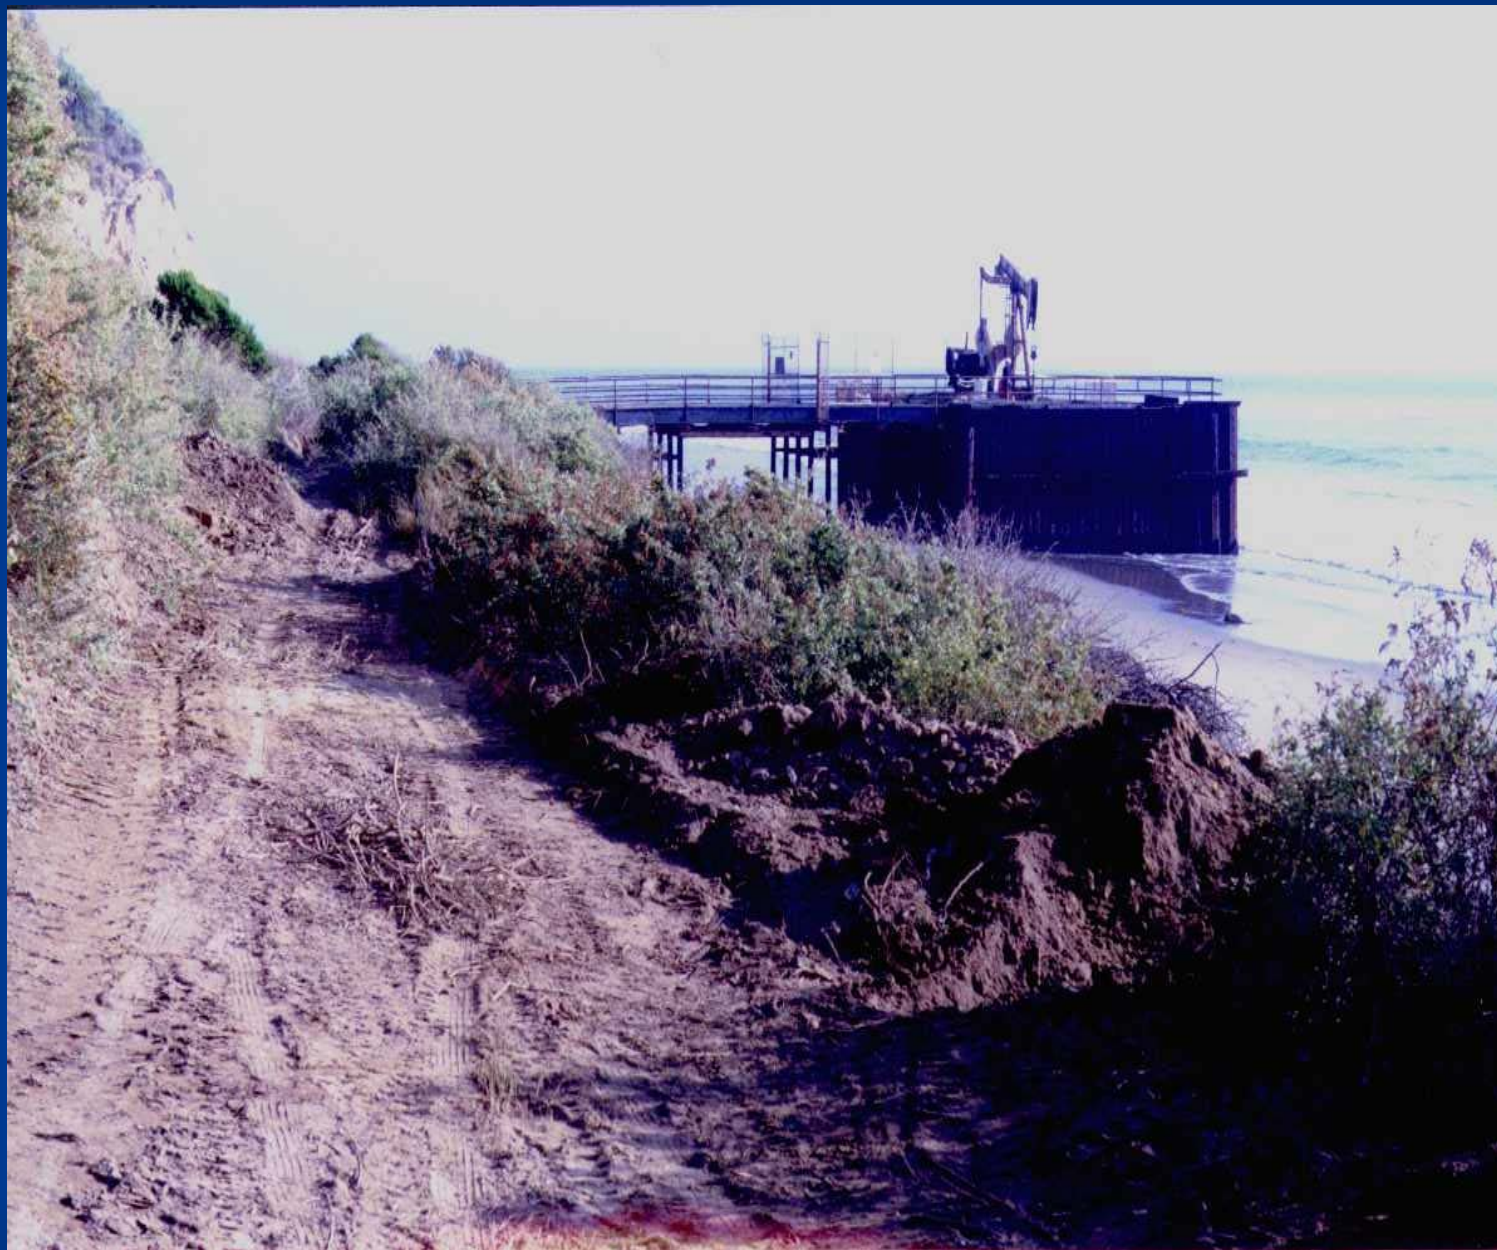
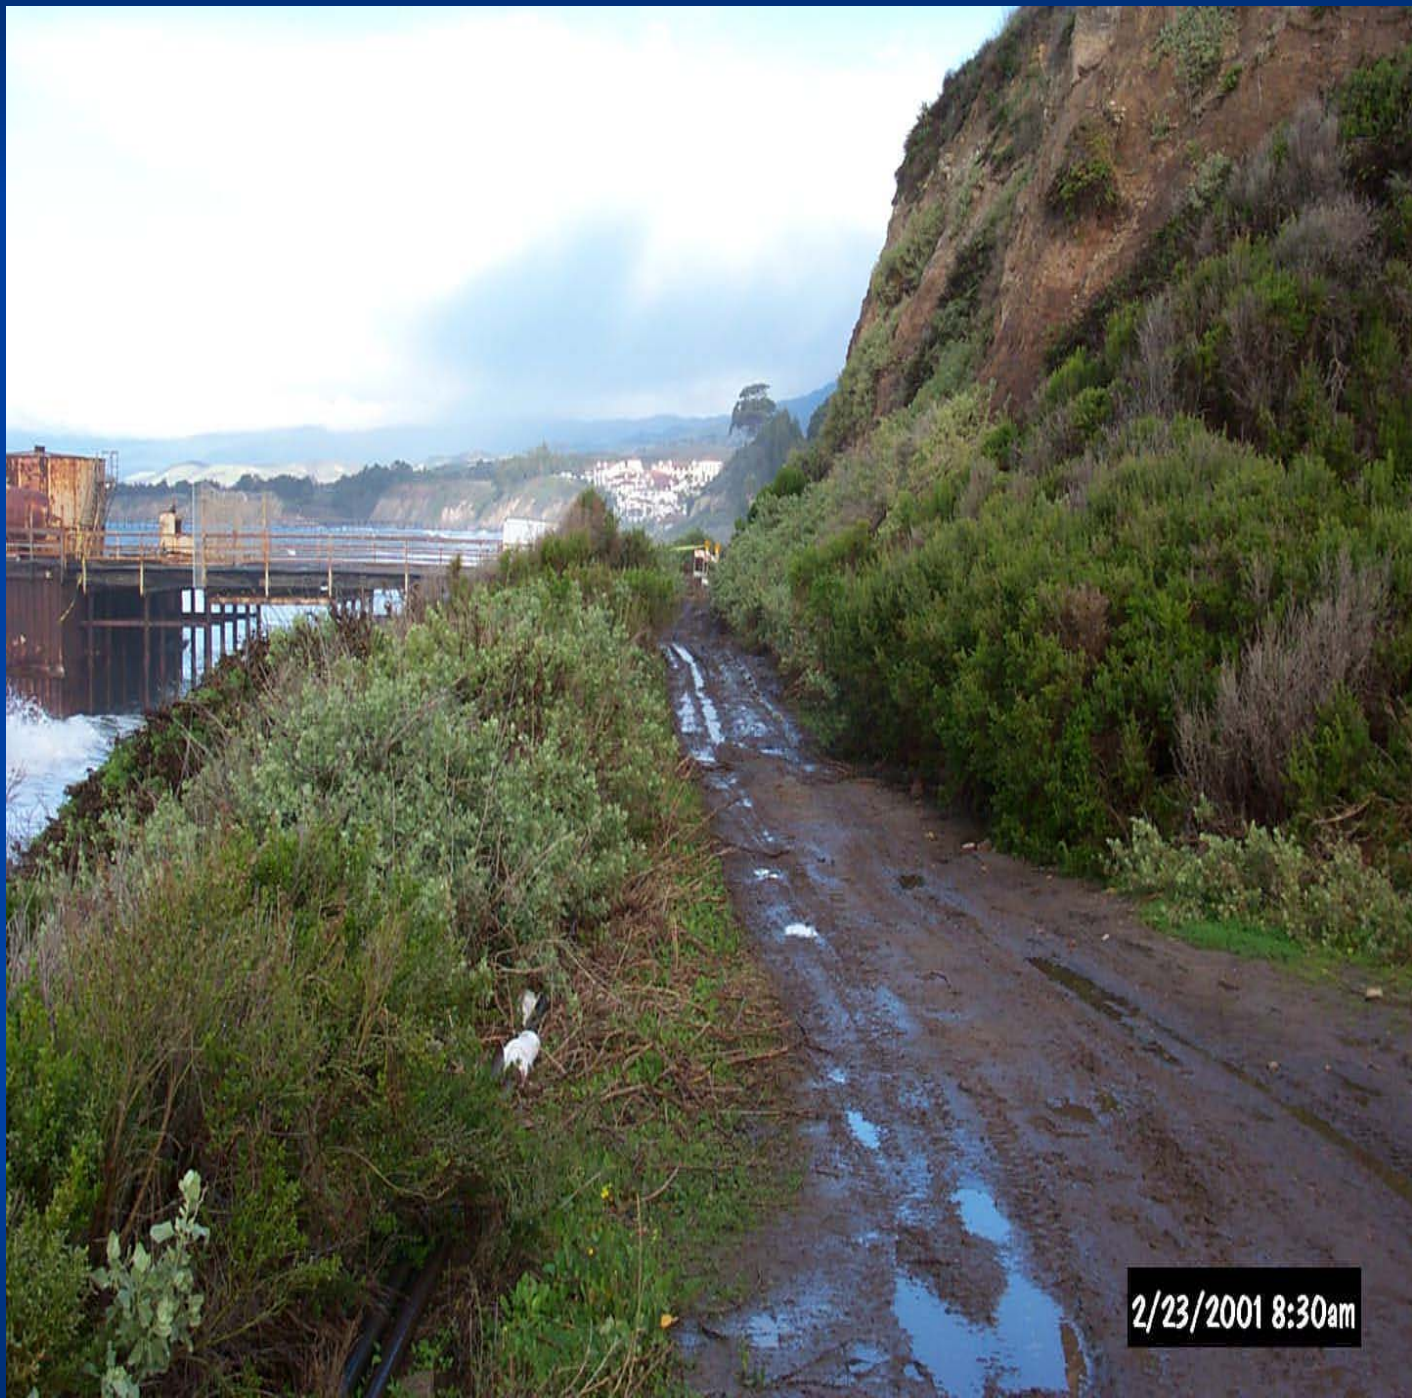
2/23/2001 8:30am

- Restricted to Reinforcement only, no expansion
- No further seaward encroachment allowed
- Remnant pipelines that were encountered were removed
- Three wetlands had appeared in the road area.
- Bluff side of the road had erosion that contained vegetation.
